**ANALYSIS OF INTEGRATED
STRUCTURES
LABORATORY STUDY**

**January 1968
Final Report**

**Prepared for DEPARTMENT OF THE ARMY
US Army Corps of Engineers
Washington, DC 20314-1000**

IN SITU REPAIR OF DETERIORATED CONCRETE
IN HYDRAULIC STRUCTURES: LABORATORY STUDY

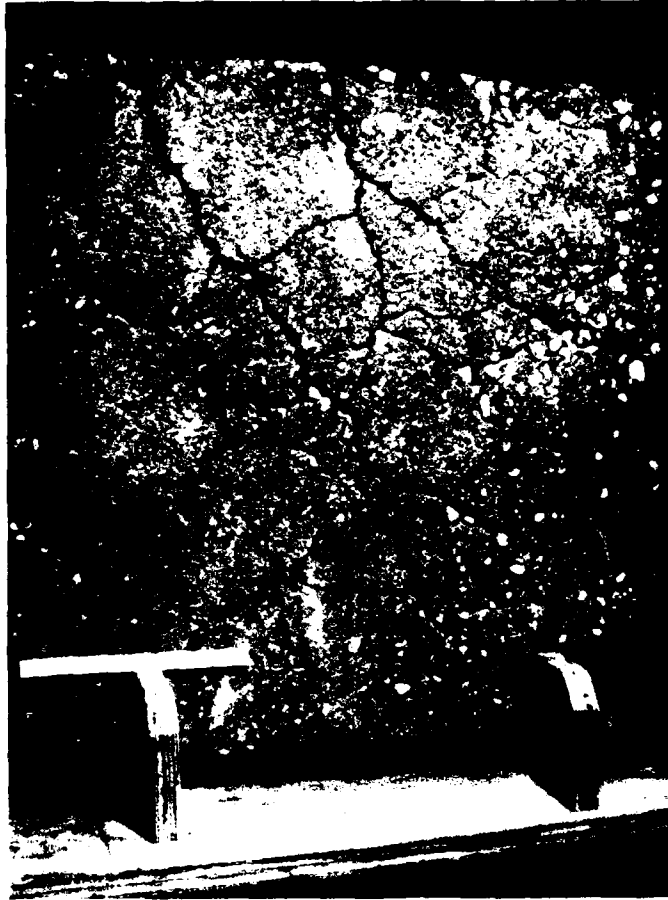
Figure 1. Typical "cracked" concrete slab.

10. The "cracked" slabs were fabricated by casting them individually into sheet metal forms. After the mixture had taken its initial set (3 to 4 hr after being fabricated), the corners of the forms were opened, and the slabs were flexed by hand until cracks began to open up in the surface. Cracks varying in width from hairline to 1/4 in. could be created this way (Figure 1). All slabs were sandblasted prior to being repaired.

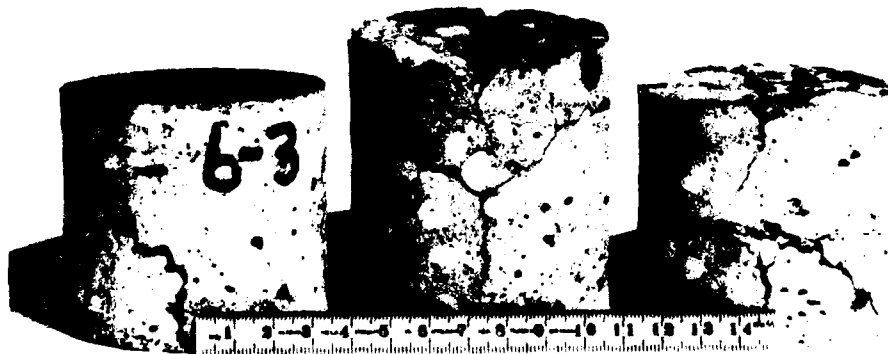
Figure 4. Cores removed from slabs repaired by injection.

30. A visual examination of the cores indicated that with the exception of those slabs which were repaired with the PCM-1100 HMW methacrylate, approximately 95% of the crack network within each slab was filled with

adhesive (Figure 4). The crack network within the slabs repaired with the PCM-1100 contained only 50 to 80% adhesive. Drainage of adhesive from the crack network within these slabs probably was due to the low viscosity and long gel time of the system.

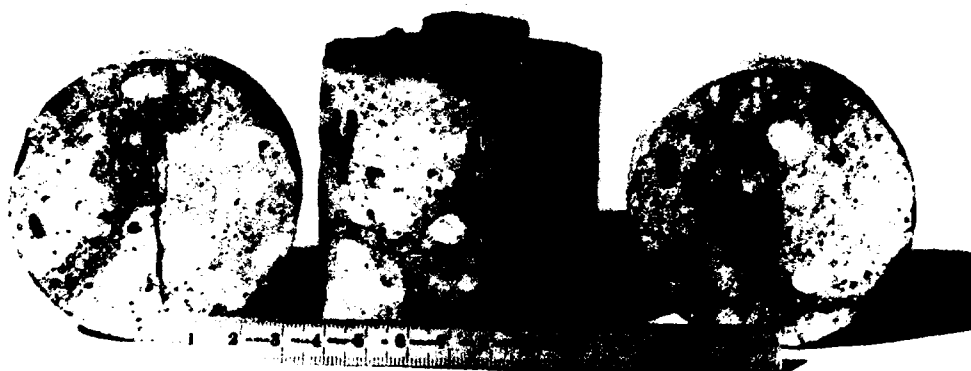
Figure 7. Cores removed from slab repaired by impregnation and injection (darkened areas around cracks indicate polymer impregnated concrete).
